DAMAGE IDENTIFICATION SEGAH BRIDGE PIER DUE TO SHIP IMPACT

¹Aco Wahyudi Efendi

¹Universitas Tridharma Balikpapan

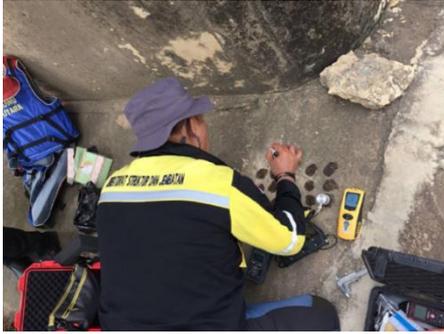
Figure 3. NDT testing at the scene of the incident, namely Pier P2 Segah Bridge

From the results of non-destructive testing in the field, the concrete quality values ranged from 22 to 30 MPa, these results were entered as parameters of the material of each checked element, namely the P2 pier and the dolphin. Then model the elements to be checked with LISA FEA.

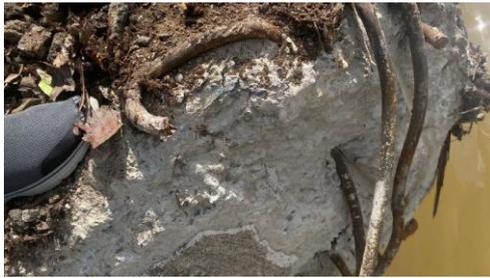
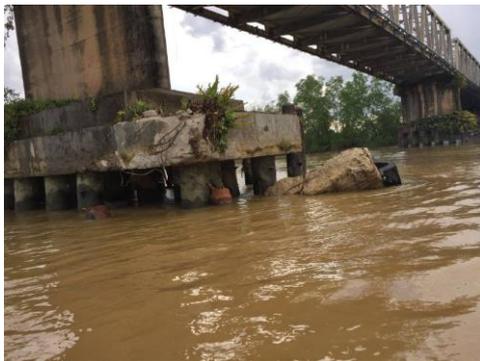
It can be seen that the damage state of existing elements in the field agrees with the results of the numerical analysis using LISA FEA V.8. in case of concrete cover thickness chip damage/fractures on the face of the pile cap, so that the reinforcement of the element is exposed and this is very dangerous for the steel material, which cannot withstand large temperature differences.

Figure 10 State of damage to existing elements in the field
